MATERIALS TECHNOLOGY FOR COAL-CONVERSION PROCESSES

**Thirteenth Quarterly Report,
January—March 1978**

ANL-78-54

Task F -- Component Performance and Failure Analysis (S. Danyluk, G.M. Dragel, W.J. Shack, and J.Y. Park)

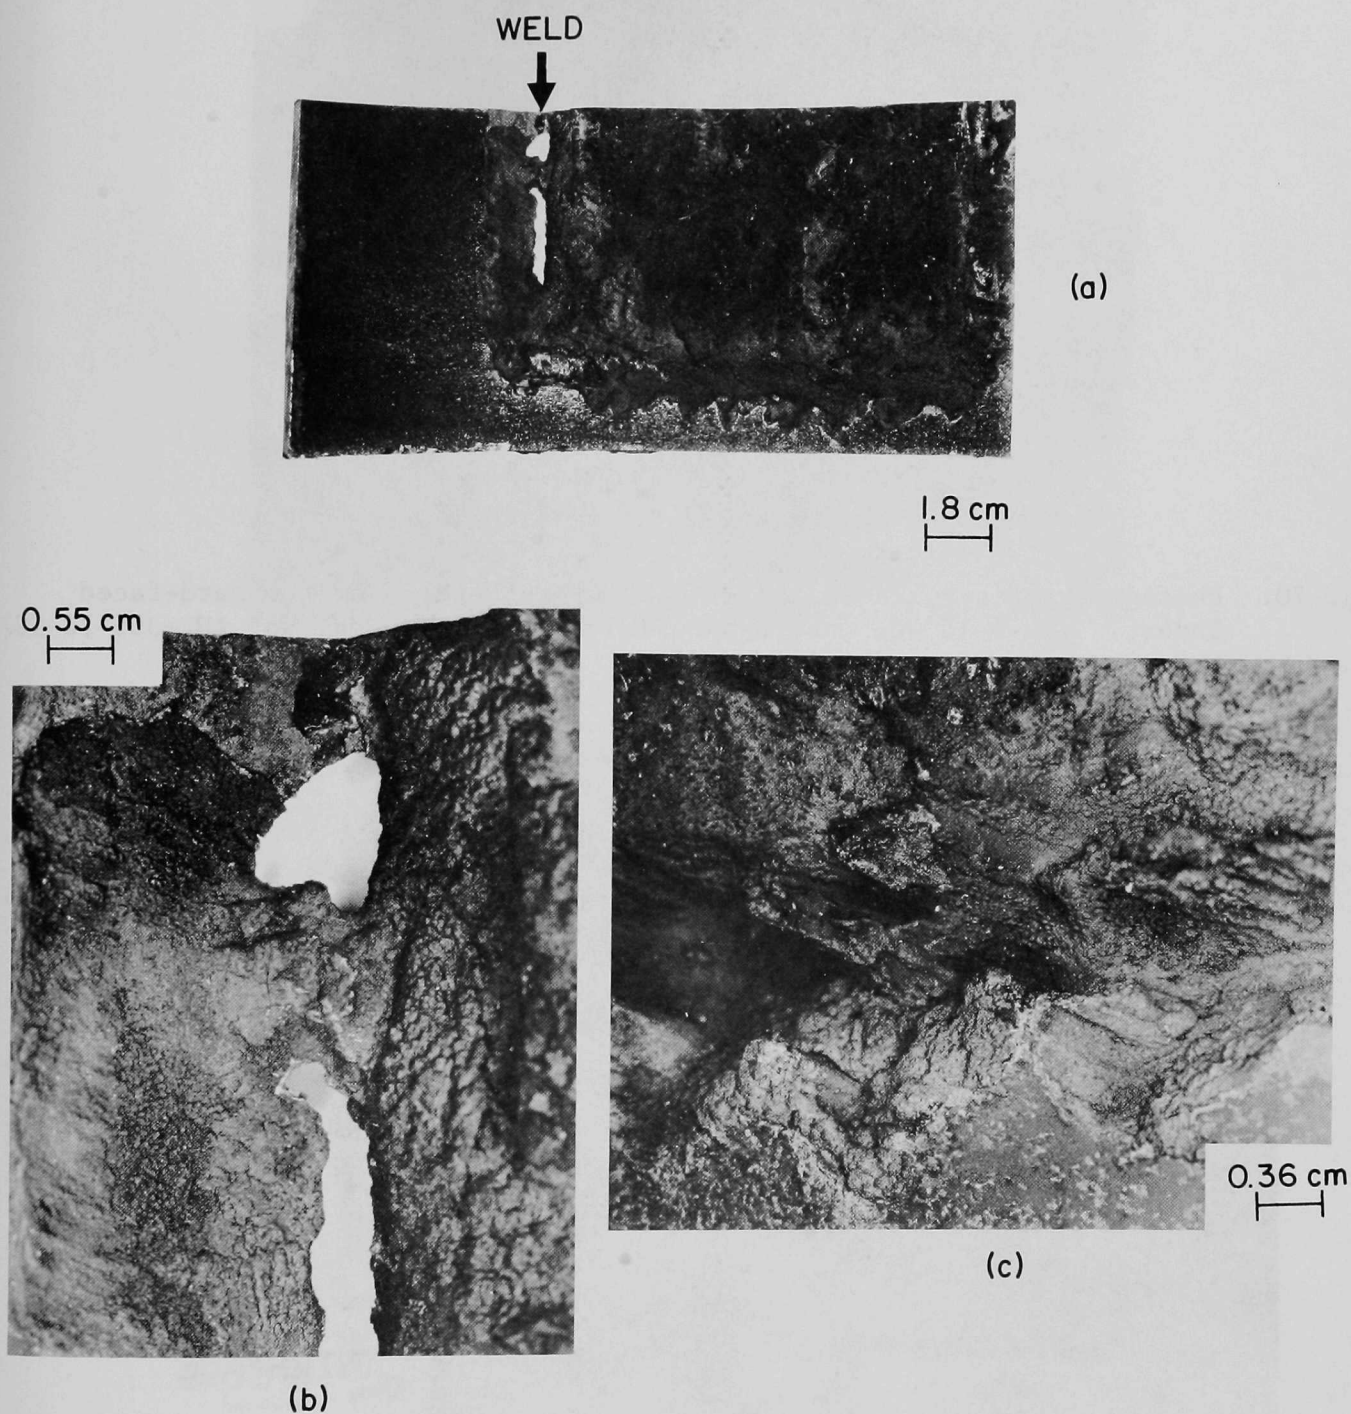
Fig. 69. Optical Photograph of a Portion of a Cobalt-based Hard-faced Cyclone Insert (a); Higher Magnifications of Two Selected Regions (b) and (c). Perforations occurred in the weld region, which was the most severely affected. ANL Neg. No. 306-78-588

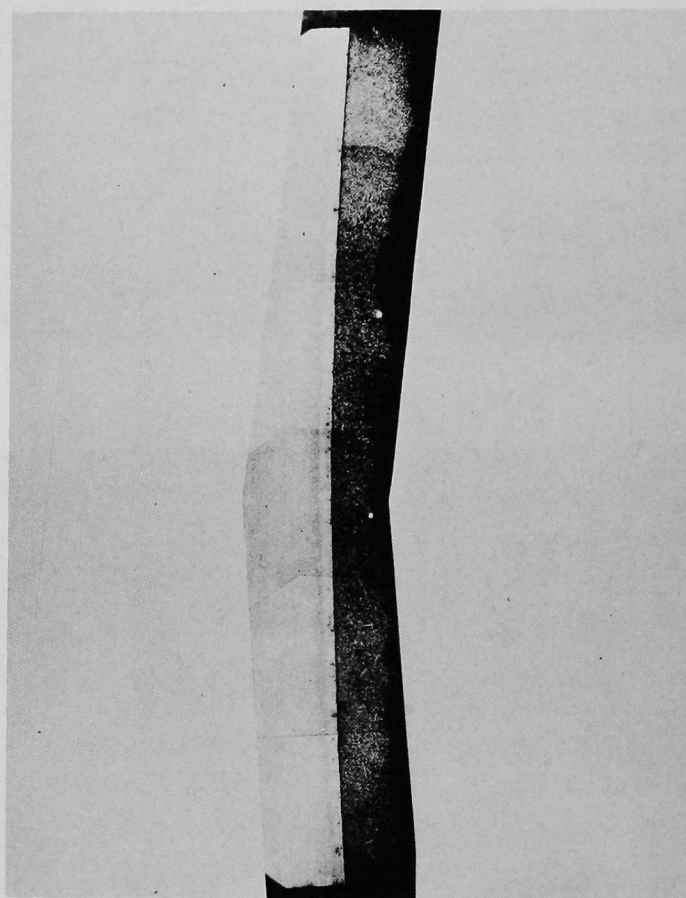
Fig. 73. Composite Photograph of the Coating, Showing the Nonuniform Coating Thickness. Neg. No. ANL-306-78-565

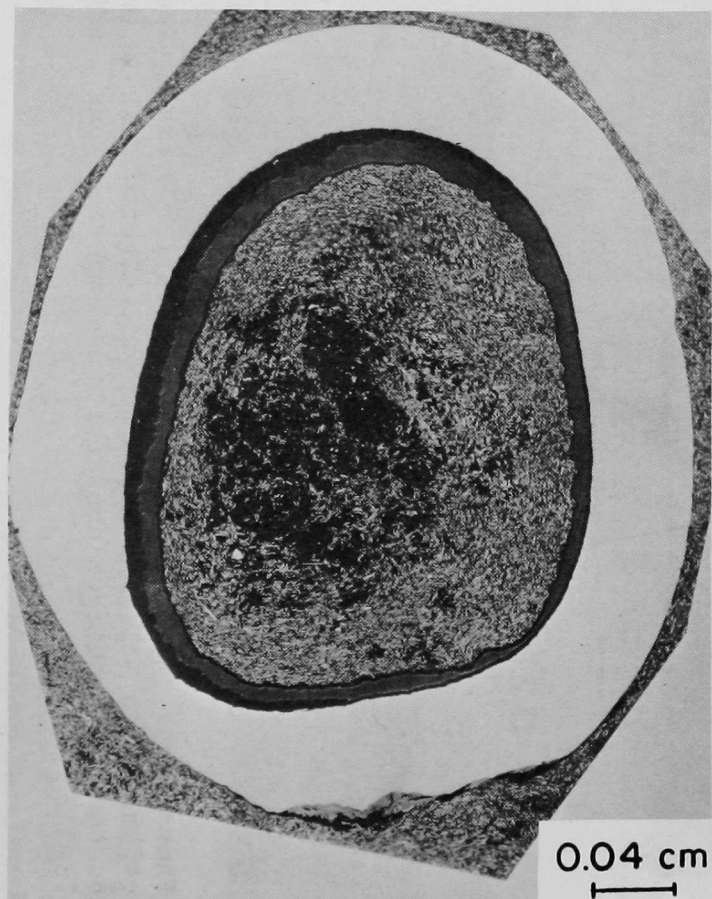
Fig. 77. Optical Photograph of a Cross Section of the Taphole Cooling Coil. A corrosion scale is seen at the ID, and localized corrosion is visible at the OD.
Neg. No. ANL-306-78-575

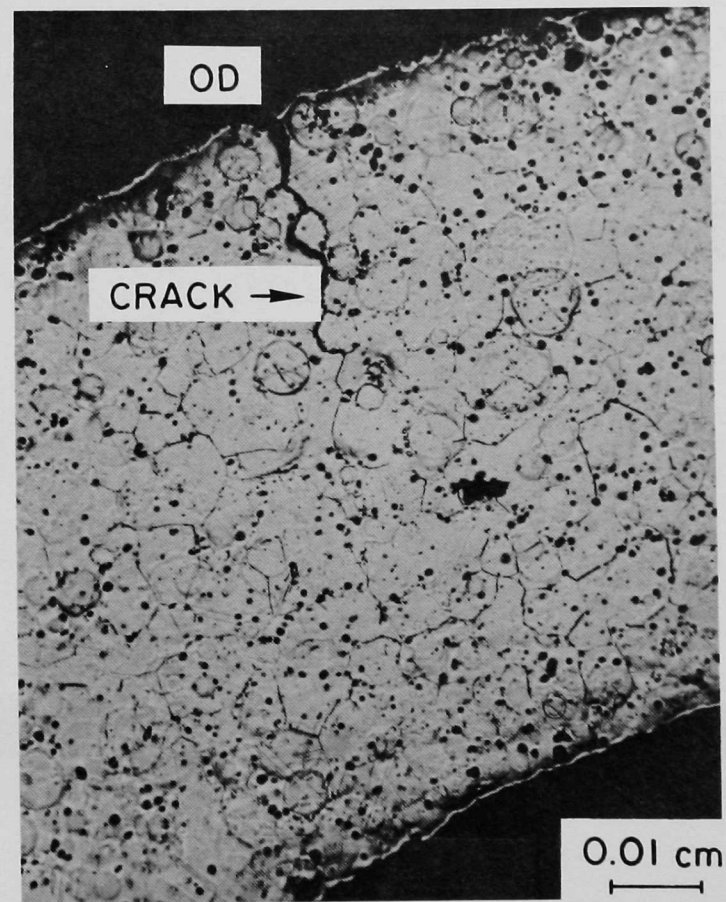
Fig. 78. Polished and Etched Micrograph of a Crack in the Hastelloy G Taphole Cooling Coil. The crack propagates from the OD toward the ID and is intergranular. Higher-magnification micrographs of this crack are shown in Fig. 79.
Neg. No. ANL-306-78-577

The failure of the Hastelloy G tube is attributed to IGSCC. From discussions with Cabot Corporation personnel, it was concluded that the alloy Hastelloy C-276 would be more resistant to IGSCC, especially since the tube is cold worked and exposed to a sulfur environment.

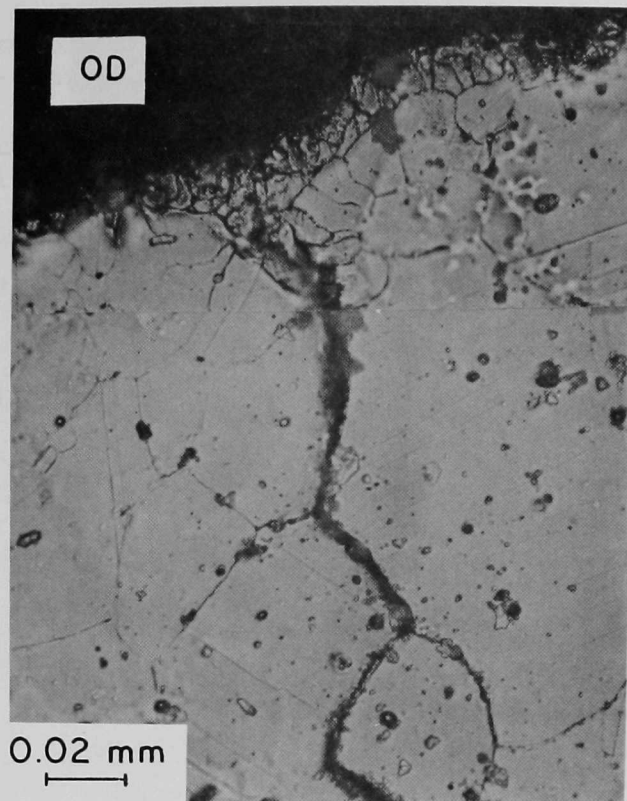
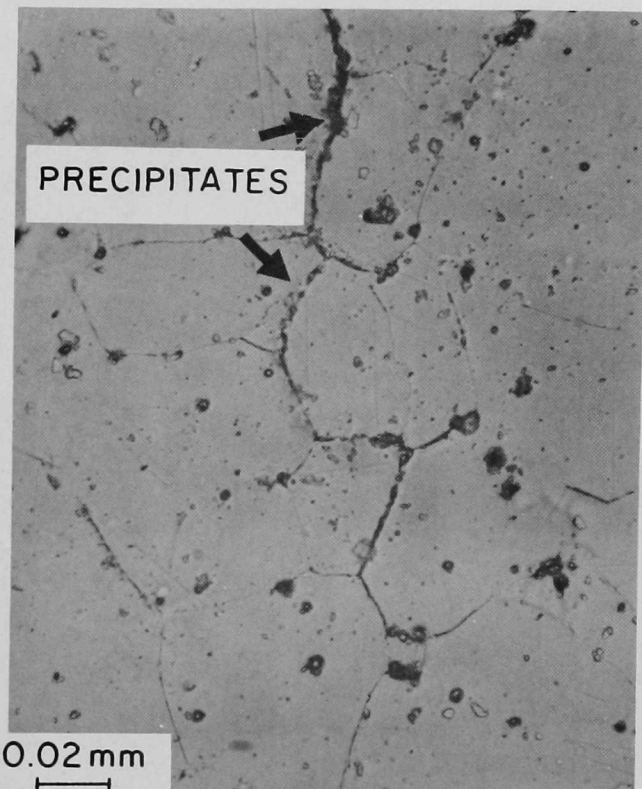
Fig. 79. Enlarged Micrographs of the Intergranular Crack Shown in Fig. 78. Recrystallization is visible at the OD where the crack initiated, and precipitates are observed at the grain boundaries. ANL Neg. No. 306-78-576
